**SELF-IMPLEMENTING ON-SITE CLEANUP AND DISPOSAL OF  
PCB REMEDIATION WASTE NOTIFICATION  
40 CFR 761.61(a)  
FORMER SILICON TRANSISTOR CORPORATION  
27 KATRINA ROAD, CHELMSFORD, MA 01824**

EPA BROWNFIELDS CLEANUP GRANT

Rev 2  
July 12, 2011

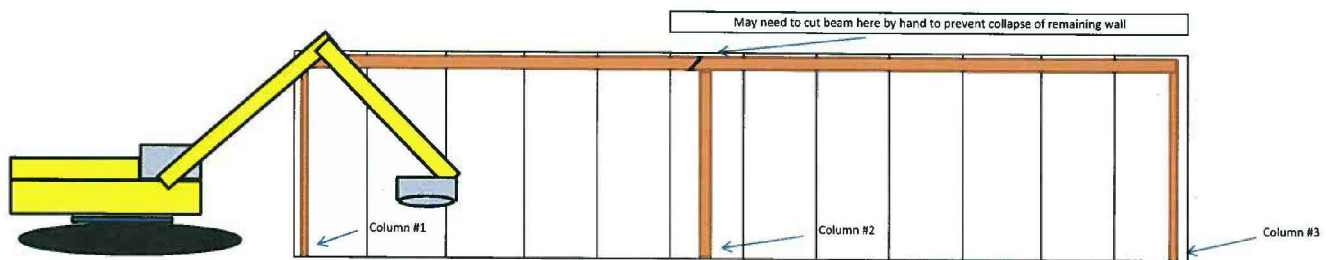
**Procedure:**

- \* Excavator demolishes Non-PCB (CMU) portion of building prior to beginning PCB Demolition/Remediation
- \* All debris from Non-PCB impacted portion of Demolition is removed from building slab area

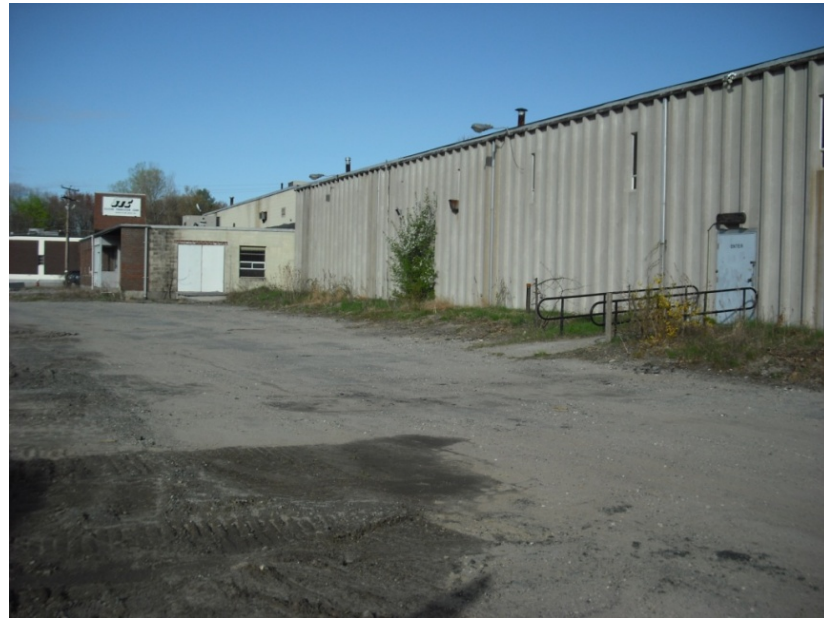
Photo 1: Southern Portion of the Building.

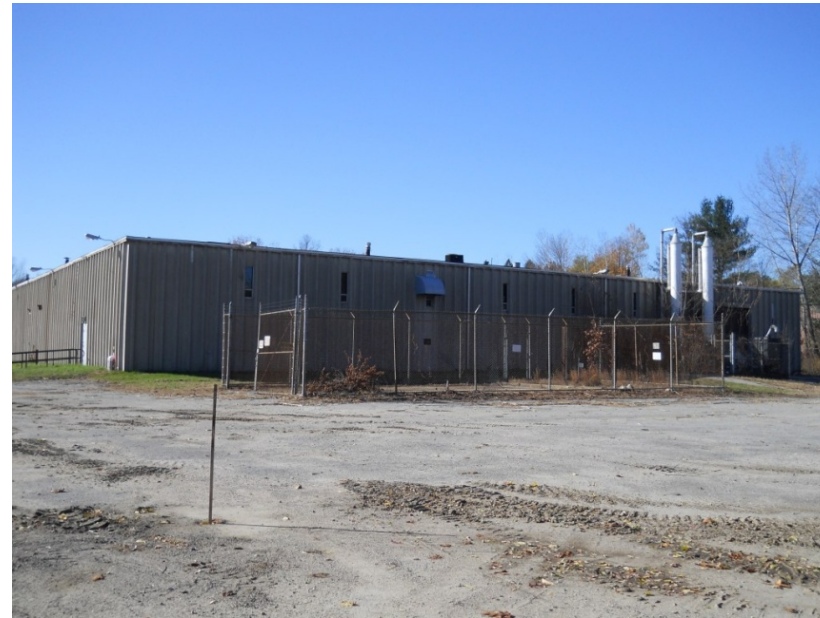
Photo 2: Eastern Portion of the Building

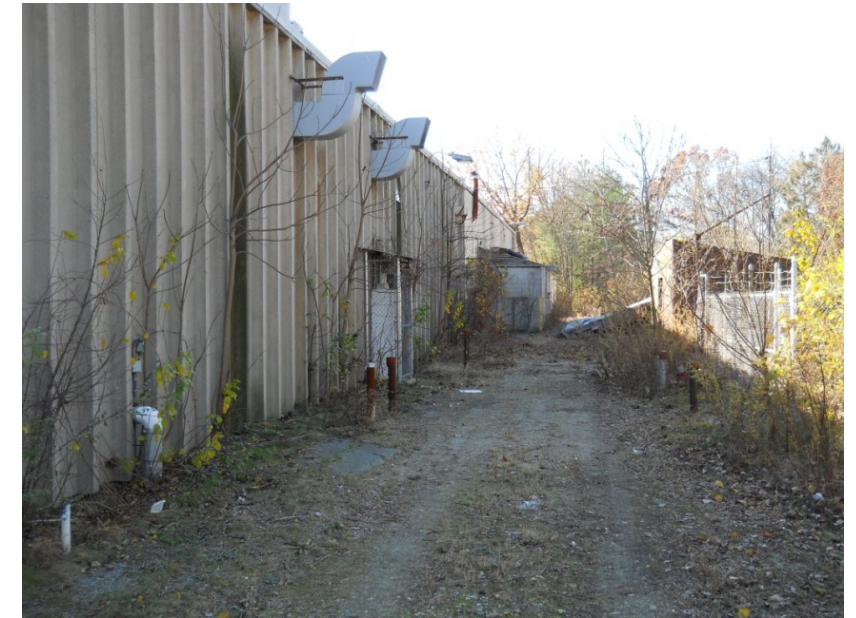
Photo 3: Northern Portion of the Building.

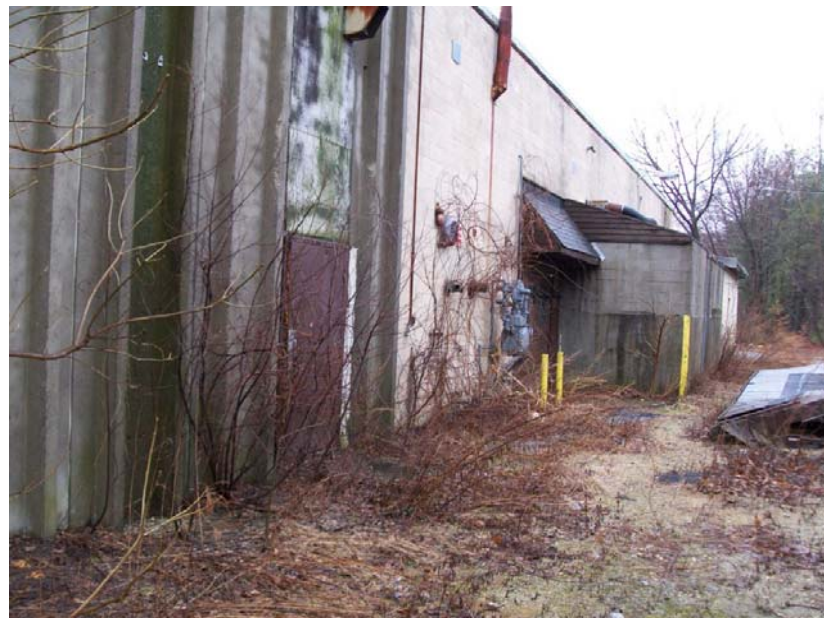
Photo 4: End of Precast Concrete Northern Side

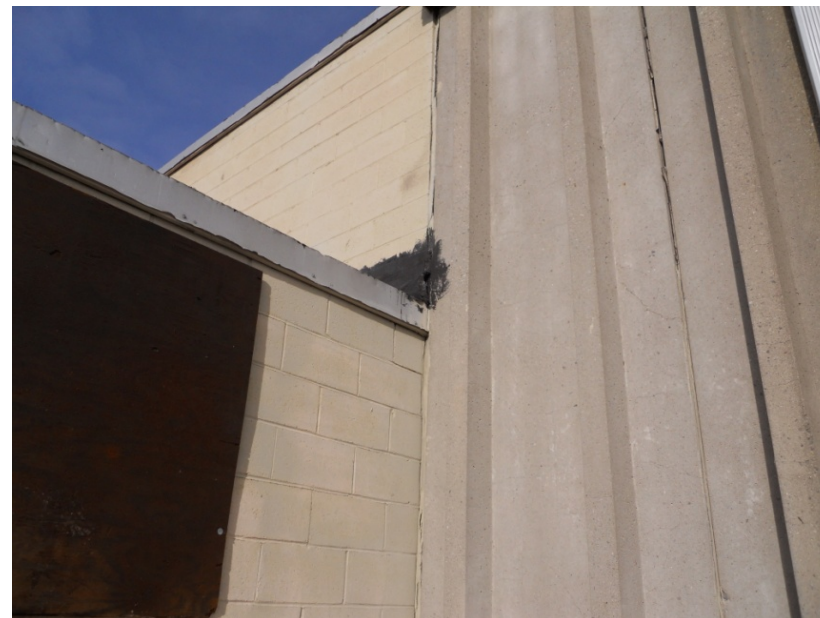
Photo 5: End of Precast Concrete Southern Side.

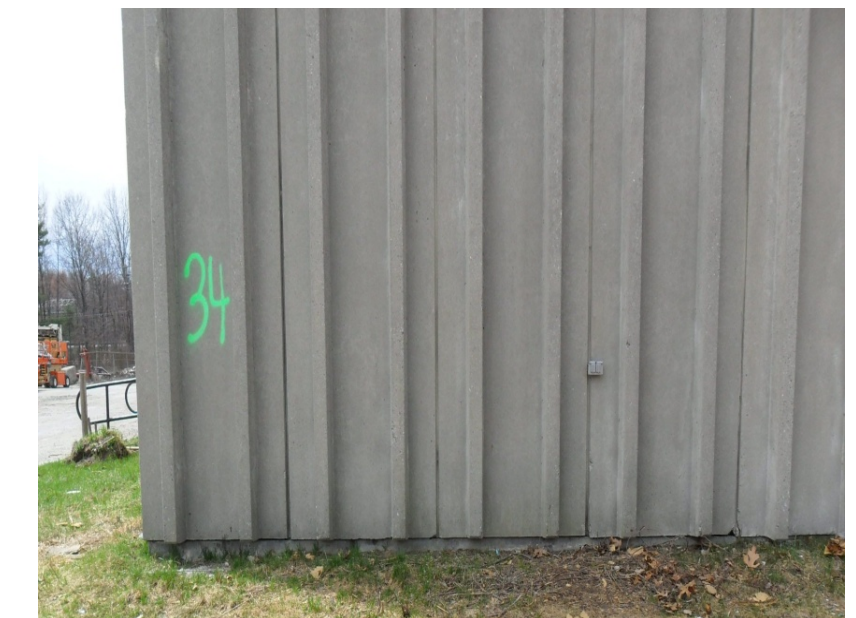
Photo 6: Precast Concrete Sections showing Expansion Joints

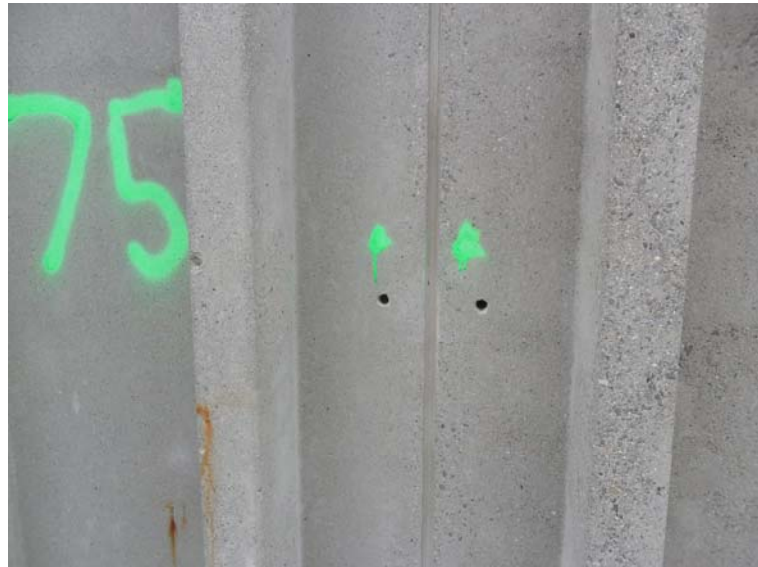
Photo 7: View of panel concrete sampling locations.

To assess the extent of PCB migration from caulk into concrete immediately adjacent to the expansion joints, concrete delineation samples were collected from the concrete immediately adjacent to the caulked Joint. Refer to Photosheet 2 for an example of a concrete sampling location with respect to the expansion joint.

Samples were collected at two locations stepped out from the expansion joint to delineate PCB impacts to the surrounding concrete. Concrete samples were collected at 2-3 inches and 4-5 inches from the expansion joint. Refer to Figure 4 for the approximate locations and results of the concrete samples.

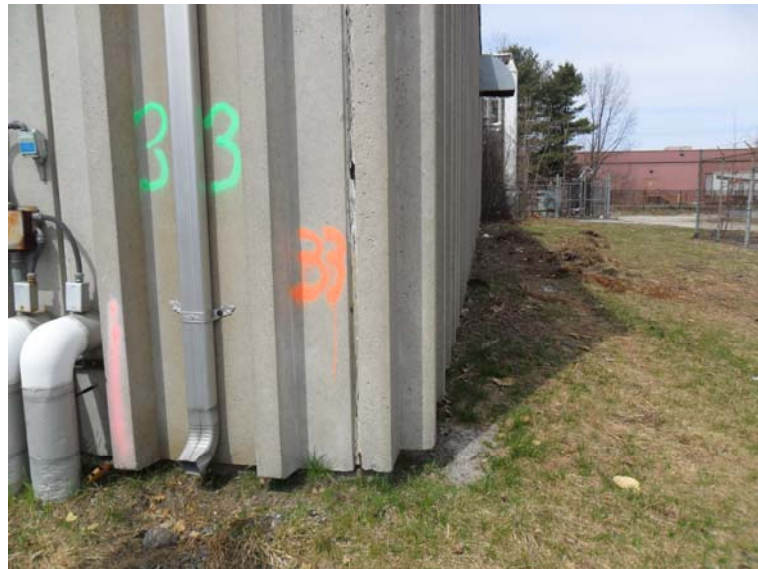
Photo 8: View of expansion joint sampling location.

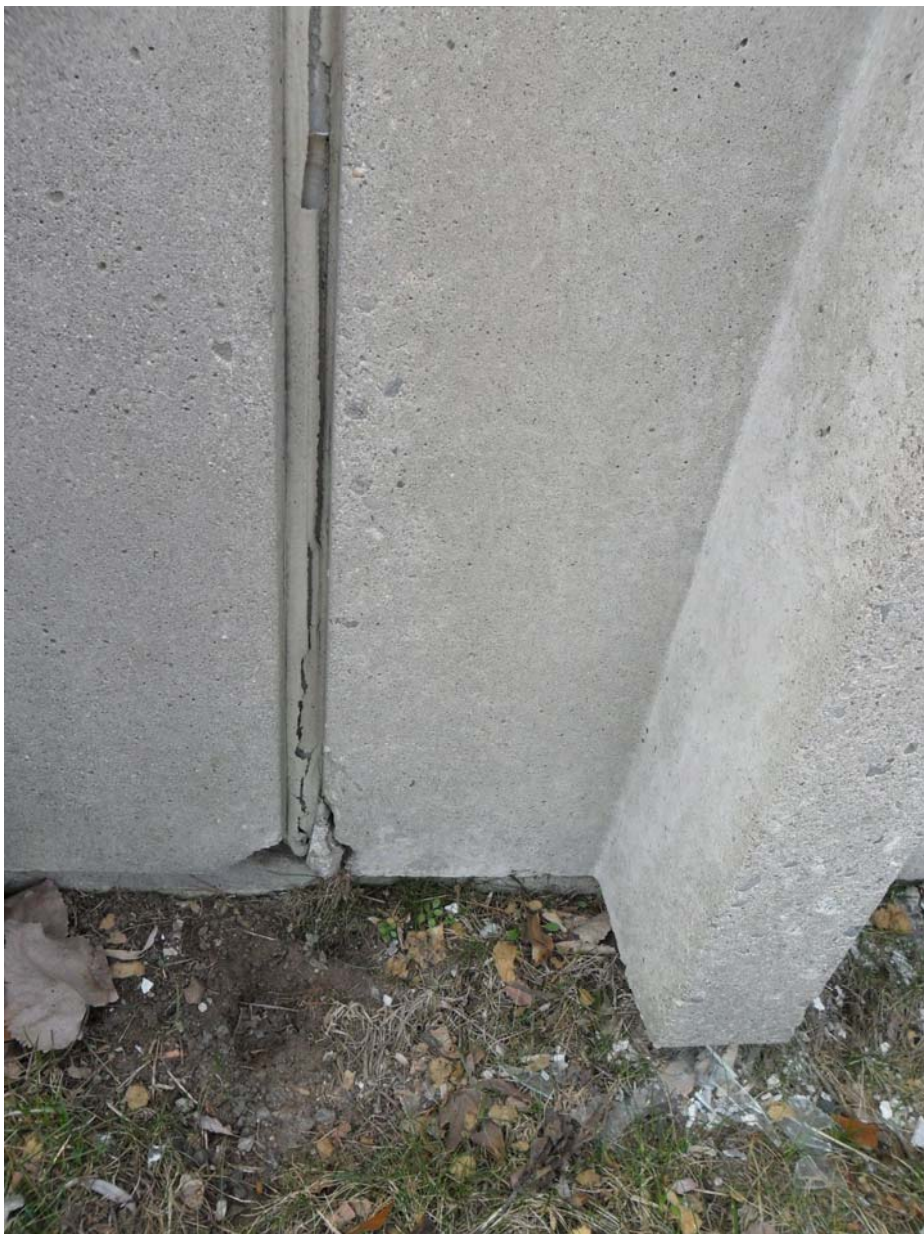
Photo 9: View 1 of expansion joint caulking and soil sampling location.

Prior to sampling, surface debris was removed to allow for the collection of a representative soil sample. A stainless steel scoop was used to collect surface soil samples from the top 2 inches of soil. Soil sample identifications were referenced to the corresponding precast concrete panel expansion joint. Soil samples were submitted to Geolabs for PCB analysis. Refer to Figure 5 for the approximate locations and results of soil samples and to Photosheet 2 for examples of soil sample locations with respect to the expansion joints.

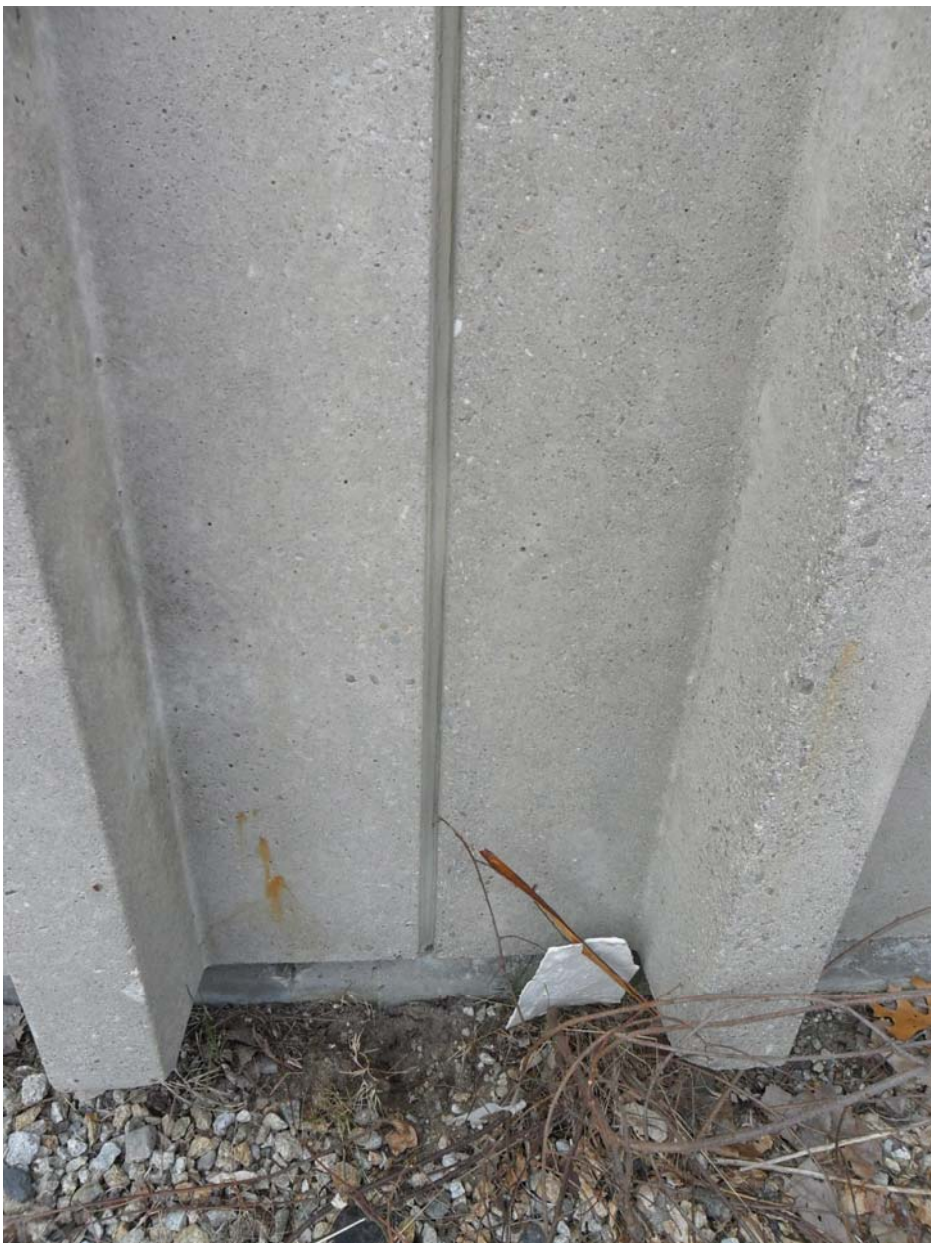
Photo 10: View 2 of expansion joint caulking and soil sampling location.
